# Journal of King Saud University - Science

# Dam safety assessment using 2D electrical resistivity geophysical survey and geological mapping

W.O. Raji a,b,\*, A.D. Adedoyin b

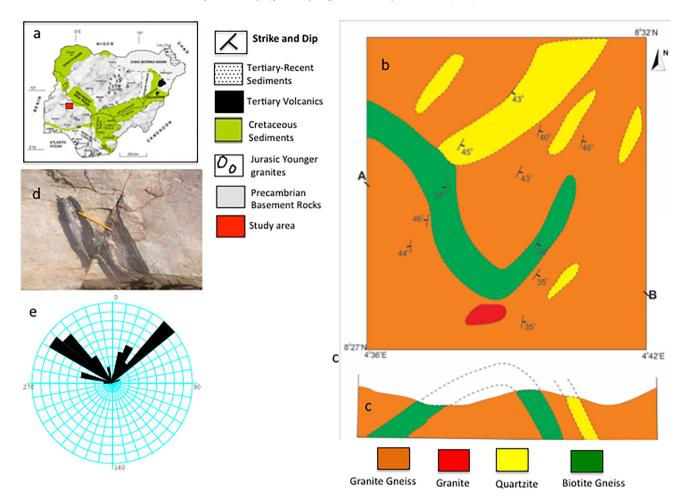
Bands and lenses of quartzite occur in some places. The quartzite is considered to be metamorphic equivalence of major quartz that filled the pre-existing fractures and faults in the area. Occurrence of quartzite around the dam suggests the presence of fractures and faults in the area. Some of the fractures and faults were seen on the exposed rock. The geological map of the study area resulting from field mapping is presented in Fig. 1b. The cross-section (Fig. 1c) reveals the presence of an asymmetric antiform with short attenuated limb. Short attenuated limb asymmetric antiform is commonly found in deformation zones (Annor and Freeth, 1985). The antiform represents the major structural elements in the study area. Other structural elements in the study area include, pinch-and -swell structure, faults, and fractures (Fig. 1d). The rocks are dipping to the west and the east with an angle ranging from 32° to 46°. Strike and dips measured in the area are plotted in the Rosette diagram (Fig. 1e). Interpretation of the Rosette diagram shows two major fracture directions: NW-SE and SE-NW fractures thereby indicating two episodes of deformation.

Fig. 1. Data from geological field mapping. (a) Geological Map of Nigeria (Obaje, 2009) showing the location of the study area; (b) Geological map of the study area; (c) cross-section AE showing asymmetric fold; (d) Sinistral fault in quartzite, (e) Rosette diagram showing the major fracture directions in the area.

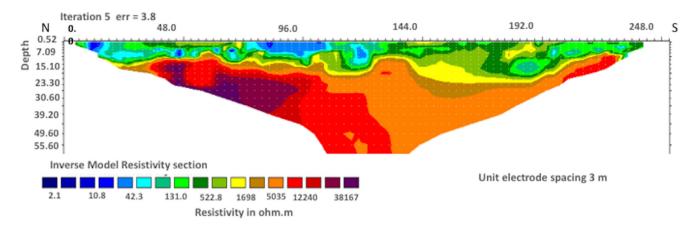
In terms of resistivity distributions, the characteristic features of the resistivity model in Figs. 3-5, (profiles 1-3) corresponding to the dam foundation are similar and difference from those resistivity models inverted from profiles 4 – 5 (Figs. 6 and 7) around the dam reservoir floor. The background resistivity in the area is about 500  $\Omega$ m – represented in green colour corresponds to the resistivity of granite gneiss -the dominant rock in the area. The red colour in the resistivity model of profile 1 (Fig. 3) represents the dam foundation at the upstream section. The high resistivity foundation structure (>12,000  $\Omega$ m) is overlain by moderately resistive granite fill. The very-low resistivity blue colour represents the watersaturated sediment. The sediments are transported by run-off water when the dam is full during rainy season. The gradual colour change, from red-yellow-green, at the top of dam foundation is a possible consequence of gradient smoothening at the boundaries of high and low resistivity materials.

Fig. 3. 2D electrical resistivity model beneath profile 1 showing the dam foundation at the upstream. The high resistivity (red colour) section shows the concrete foundation below water level.

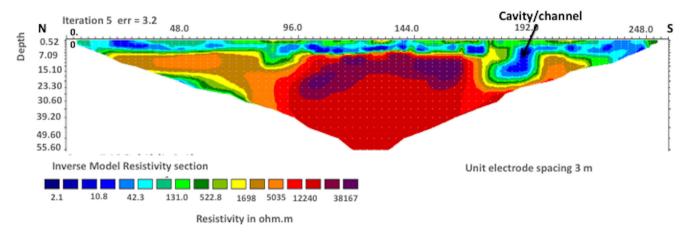
Profile 2 (Fig. 4) show the resistivity model of the dam foundation at the downstream section. The high resistive (red) portion of the resistivity model represents the dam foundation at subsurface.

**Fig. 4.** 2D electrical resistivity model beneath profile 2 showing dam foundation at the downstream. The blue section with arrow shows the cavity in the foundation saturated by water.

The foundation is overlain by moderately-resistive support granite fills down the spillway. The laterally continuous low-resistivity (blue colour) is interpreted as sandy materials infiltrating the granite fills. The sandy materials were derived from the sediment transported by water from the land. The low resistivity structure at

about 192 m in Fig. 4 indicates a weak zone in the downstream section of the dam. The structure is interpreted as a cavity or a channel. The weak zone is a source of threat to the dam foundation. It could be a result of void in the dam foundation that has grown over time due to water infiltration.

To ascertain this, the geoscience team planned to repeat the 2D resistivity survey in the near future. It is believed that time-lapse image of the dam will reveal changes in the size of the channel thereby allowing a better interpretation of the structure. However, personal communication with a structural engineer informed that the channel does not constitute a serious threat to the dam at this time, because it is located on the downstream section (exterior wall) of the dam. If the cavity expands over time, it may affect the interior wall of the dam. Structures such as cavity and channel may be formed by the dissolution of mineral or rocks aggregates and it may grow bigger due to water infiltration (Owen, 1983; Metwaly and Alfouzan, 2013). The section of the dam has been referred to expert engineers for further studies. Profile 3 (Fig. 5) revealed the right edge of the dam foundation (high resistivity) and some parts of the bedrock beneath the reservoir floor in the upstream and downstream sections. The dam edge is indicated by the high resistivity values (red colour) at the centre of the resistivity model. The low resistivity values to the left and right of resistivity model represent the bedrock around the edge of the dam. The bedrock is characterized by lower resistivities suggesting the presence of weathered and water-saturated rocks.

sent points of water seepage in the dam. A cavity was delineated in the downstream section of the dam. The cavity constitutes a potential threat to the dam and it has been referred to structural engineers for detailed study. Findings from geological mapping support the results of geophysical investigations. Overall the study confirms the appropriateness of electrical resistivity survey for investigating dam and similar engineering infrastructures. The methods and procedure used for the study can be applied to any dam and other similar engineering infrastructures to assess their safety status and proffer remedial action where necessary, in order to prevent sudden collapse of the infrastructure.

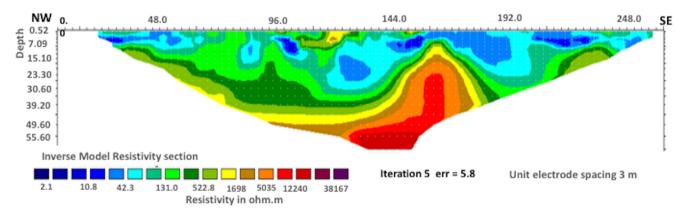
Fig. 5. 2D electrical resistivity model beneath profile 3 showing some weathered sections (beep blue colour) in the dam reservoir floor and the protruding edge of the dam foundation (red).

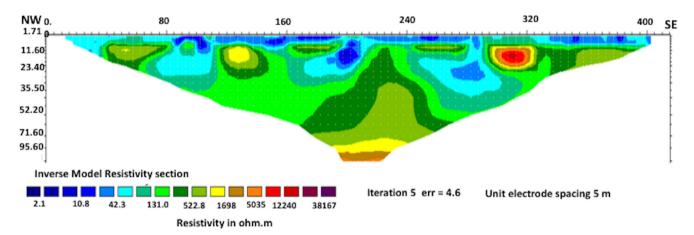
Fig. 6. 2D electrical resistivity model beneath profile 4 showing the dam's reservoir floor. The blue patches show water-saturated weathered rock.

Profiles 4 and 5 (Figs. 6 and 7) show the electrical resistivity property of the rocks beneath the reservoir floor. The two tomographic images are dominated by low resistivities ranging from 2 to 1698  $\Omega$ m. The very low resistivity values suggest that the rocks have been weathered and infiltrated by water. The blue

patches in the background green colour indicated possible areas of internal erosion and water seepages. Internal erosion and seepages are flash points of excessive water loss. The blue patches are prominent on the tomographic image of profile 4 (Fig. 6) at lateral distances equivalent to 85–100 m, 190–210 m. A fracture is delineated in the reservoir floor along profile 5 (Fig. 7) at about 300 m. The fracture is suggested by the vertical resistivity contrast (represented by yellow-green vertical lines) separating the green massive structures on the left from the brownish massive structure on the right. The fracture is vertically oriented and trending in the NE-SW direction. The fracture delineated in the resistivity model is supported by the fractures mapped during the geological fieldwork (Fig. 1d). The orientation of the fracture also corresponds to the fracture direction interpreted from the rosette diagram (Fig. 1e).

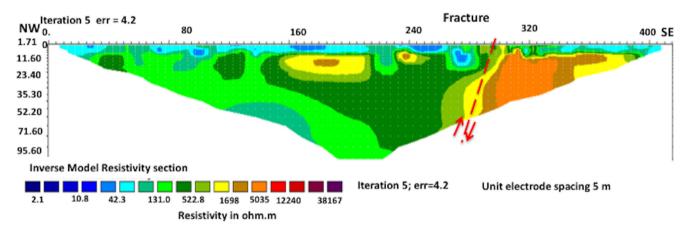
Fig. 7. 2D electrical resistivity model beneath profile 5 showing a fault in the dam reservoir floor similar to the structure mapped on the surface (Fig. 1) during geological mapping.
