Development of a culvert inventory and inspection framework for asset management of road structures

Mohammad Najafi *, Deepak Varadarajan Bhattachar ¹

Center for Underground Infrastructure Research and Education (CUIRE), Department of Civil Engineering, The University of Texas at Arlington, Box 19308, 428 Nedderman Hall, Arlington, TX 76019, USA

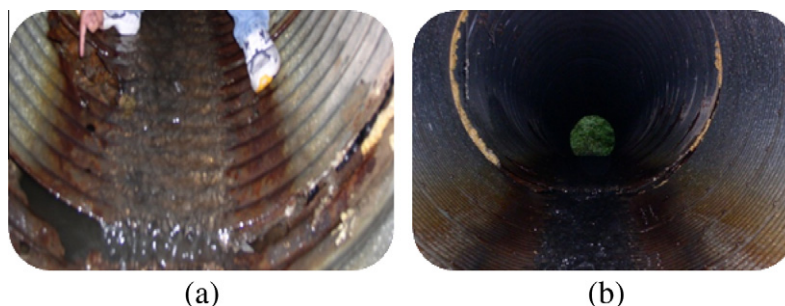
The culvert 25001273A01 (1200 mm/48 in. circular CMP) located in Ingham County was about 65 years old and was scheduled for replacement in 2006. The invert was damaged (formation of a big hole, about one in. in diameter) and corroded in few places as shown in Fig. 2(a). The headwall and wingwall at the culvert outlet had major spalling and cracks in few places. The embankment had moderate erosion around the structure. A layer of the concrete bed had eroded and perched due to high velocity of flowing water at the outlet. The water was flowing back at the inlet due to serious misalignment of the culvert from its design (Fig. 2(b)). The road above the culvert looked new and was in excellent condition. The condition rating for this culvert is as shown in Table 13.

Figure 2 (a) Big hole and corrosion in the invert of the culvert 25001273A01. (b) Misalignment of the culvert 25001273A01.

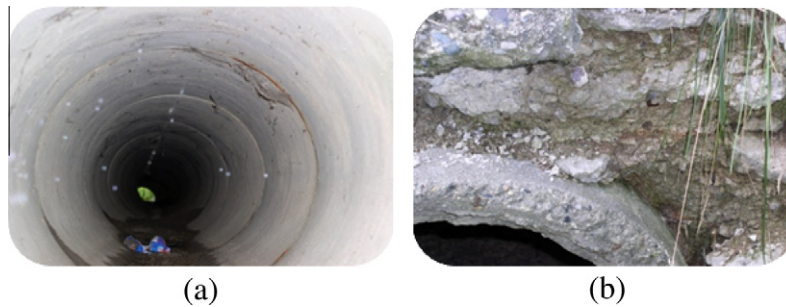
The culvert 31000131B01 (600 mm/24 in. Circular Concrete) located in Shiawassee County was about 65 years old and was on the verge of failure. Age deterioration was significant with heavy vegetation surrounding the culvert. The headwall was partially broken as shown in Fig. 3(b); minor cracks and major spalling were found inside the culvert structure. Moderate misalignment of the culvert was found as shown in Fig. 3(a). The erosion around the headwall was moderate. This may be one of the reasons for headwall failure. The roadway

**Figure 3** (a) Misalignment of the culvert. (b) Failure of the headwall due to heavy spalling.

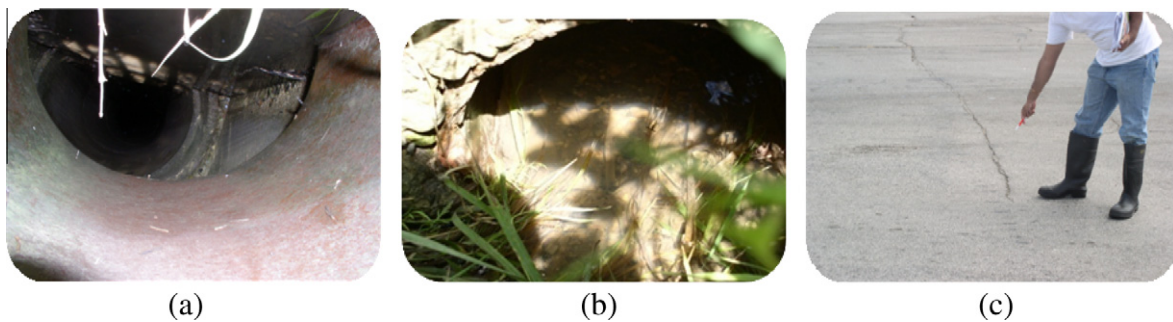
**Figure 4** (a) Significant misalignment of the culvert structure. (b) Vegetation and heavy spalling in the headwall. (c) Cracks on the roadway surface.

The culvert 31000131B02 (600 mm/24 in. Circular Concrete) located in Shiawassee County was also about 65 years old. The invert was eroded due to heavy transportation of soil sediment through the culvert. Flow was obstructed at the invert due to deposition of soil sediment. The joint opening in the middle of the culvert was significant which resulted in soil

infiltration and misalignment of the culvert as shown in Fig. 4(a). The culvert headwall and the barrel were partially broken as shown in Fig. 4(b). This can be due to heavy superimposed load or due to significant soil erosion surrounding the headwall. The culvert was surrounded by heavy vegetation. The roadway had minor settlement and cracks as shown in Fig. 4(c) This may have been caused by the joint opening in the middle of the culvert, and ultimately may lead to shape

deformation of culvert or loss of backfill material. Overall the culvert deterioration was very significant. The condition rating system for this culvert is as shown in Table 13.

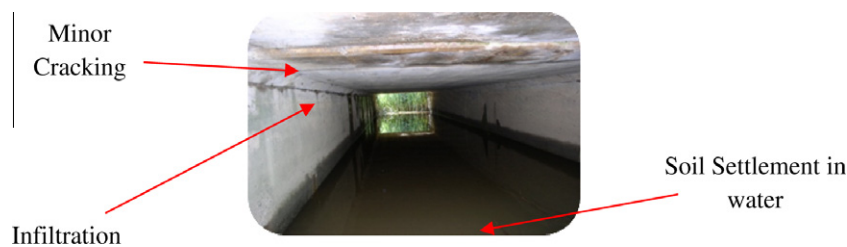
**Figure 5** Condition of culvert 31000131B04.

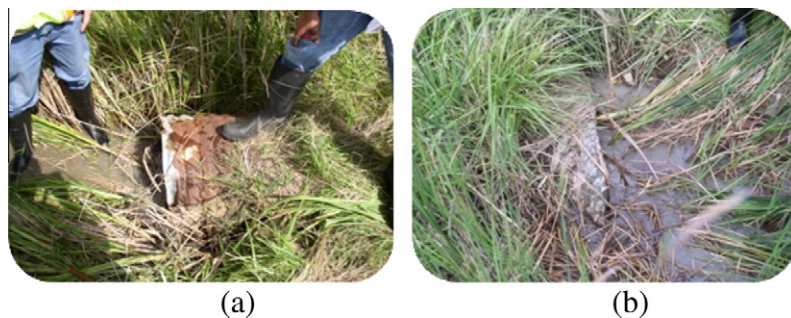
Figure 6 (a) Corrosion on the outside surface of the CMP. (b) Total failure of the culvert end.

The culvert structure 31000131B04 (600 mm/24 in. CMP Circular) was totally failed. The pipe was completely closed on one side. Overall, the pipe was corroded inside and outside as shown in Fig. 6(a) and (b). The roadway has a pothole and moderate cracks due to culvert deterioration. The embankment was partially eroded. The culvert has no end treatment. The condition rating for this culvert is as shown in Table 13.

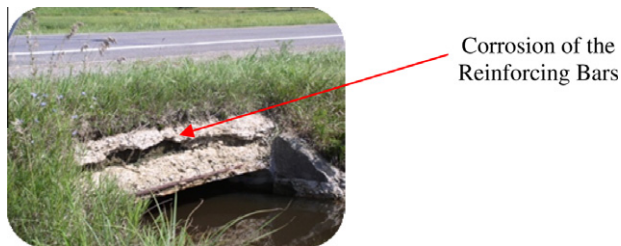
Figure 7 Condition of culvert structure 31000131B05.

The culvert 31000131B05 (Slab – 2.4 m/8 ft opening, 2.1 m/ 7 ft rise, Rectangular in shape) is located in Shiawassee County and was also about 65 years old. This concrete culvert was deteriorated, but functioning normal. There was moderate deposition of soil sediments over the invert, and headwalls and wingwalls were heavily damaged with spalling. This has

led to heavy corrosion of the reinforcing bars as shown in Fig. 7. There was minor cracking between the footing and wingwall; the roadway above the culvert has potholes and major cracks. The embankment was heavily eroded. The condition of the footing looks good. Overall, the culvert is in poor condition. The condition rating for this culvert is as shown in Table 13.
