# Vascular plants census linked to the biodeterioration process of the Portuguese city of Mazagan in El Jadida, Morocco

Built in the early XVI<sup>th</sup> century, Mazagan is one of the first fortifications constructed in North Africa by Portuguese explorers on their way to India. Among the factors of degradation facing the Portuguese city, we were particularly interested in the action of plants that develop there. The objective of our study is to establish a list of plant species that develop on materials and to analyze the potential effects of that vegetation on substrate and thus on monument deterioration. We carried out a systematic sampling in Mazagan. After sampling and identification of plants, we established a list of 57 species belonging to 25 families and 54 genera. The Asteraceae family is the richest in species. The therophytes are the most represented in Mazagan with a proportion of nearly 53% followed by Hemicryptophytes that contain nearly 26% of the listed species. These two biological types may have a fasciculated or pivotal rooting that sinks into the substrate leading to its crumbling. Other biological types such as phanerophytes, chamaephytes and geophytes are

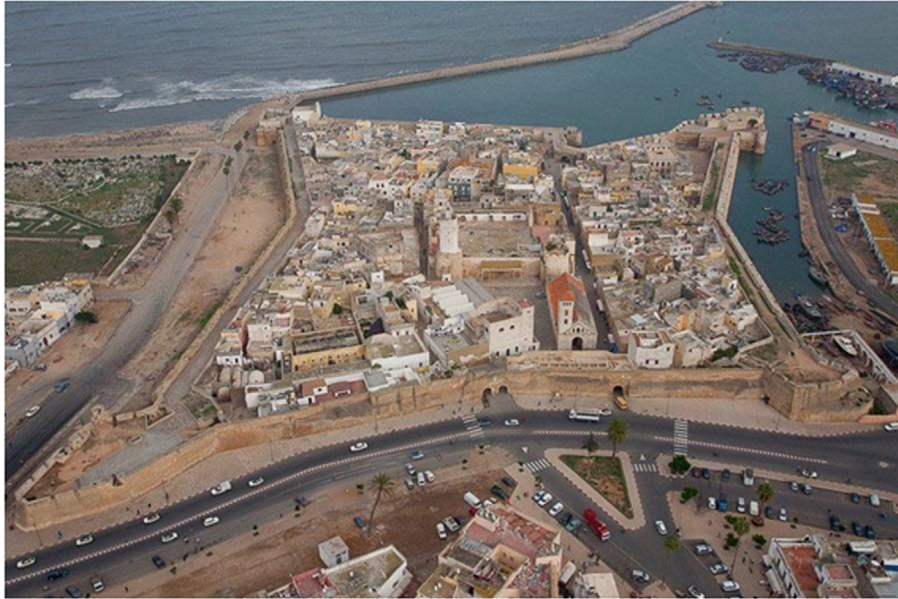
The fortress of Mazagan, located at the Atlantic coast in south of the city of El Jadida (Fig. 1), is circumscribed by imposing walls and has currently four bastions (Fig. 2). From the Portuguese era, only

Fig. 2. Aerial photo of Mazagan (Derif, 2016).

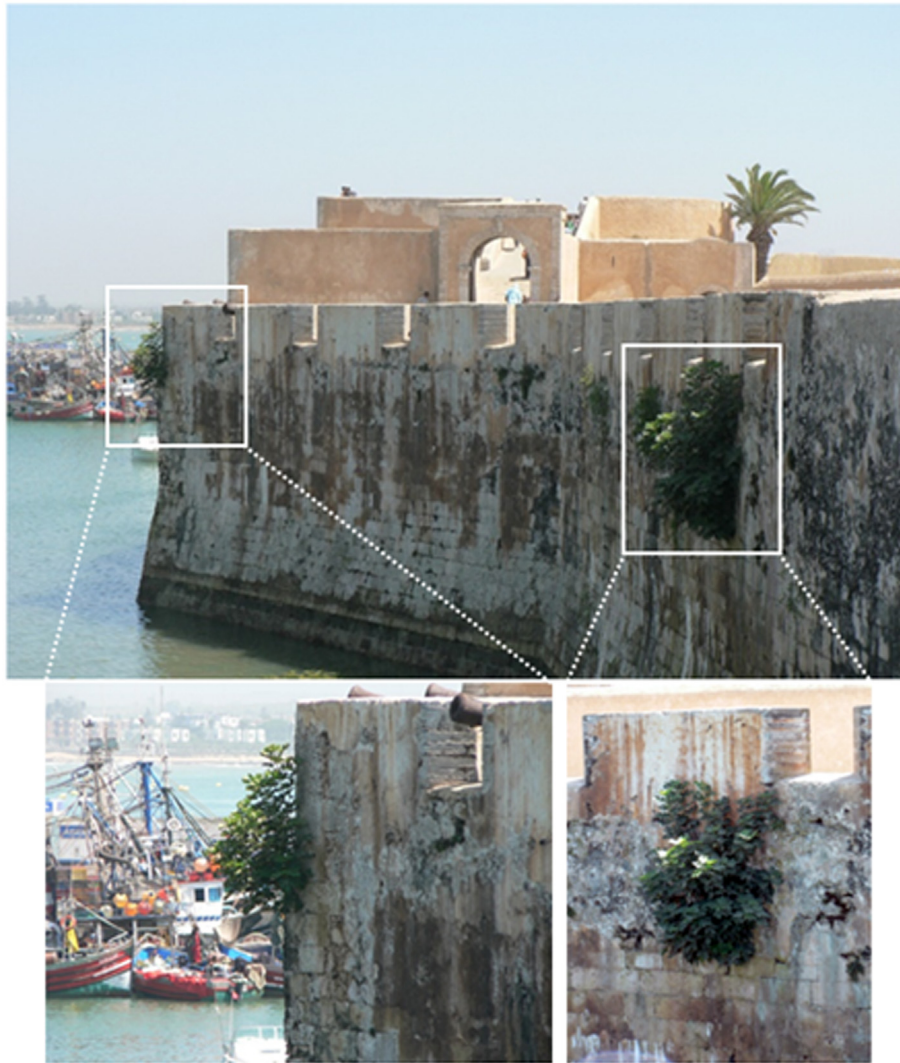
Biological colonization occurs on different supports. On limestone walls of the ramparts (Fig. 6) grow plants whose roots penetrate the joints.

**Fig. 6.** Development of vegetation on limestone walls.

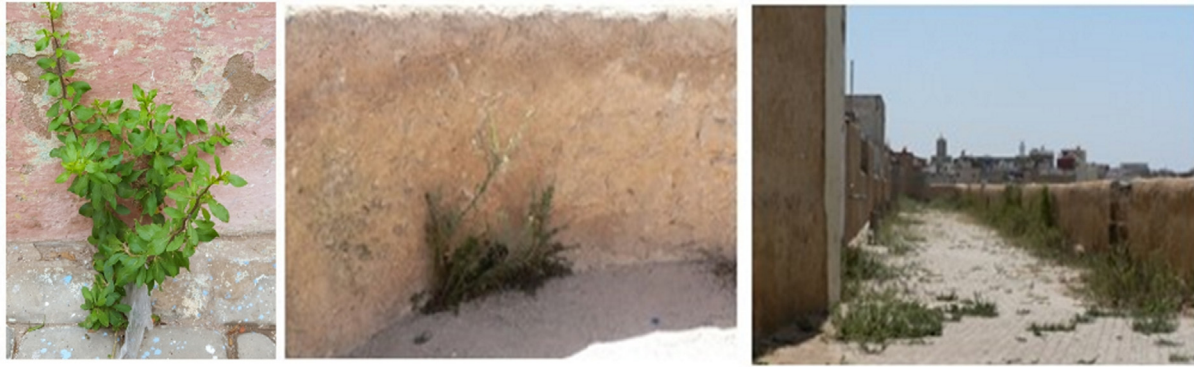
The base of the internal side of walls of the ramparts, covered with a coating of lime, is often covered with plants due to water retention (Fig. 7). Important vegetation that flourishes at the expense of joints, which are less resistant and relatively rich in nutrients often, invades the walkways pavement.

Fig. 7. Proliferation of vegetation at the base of the walkways walls of the Portuguese city.

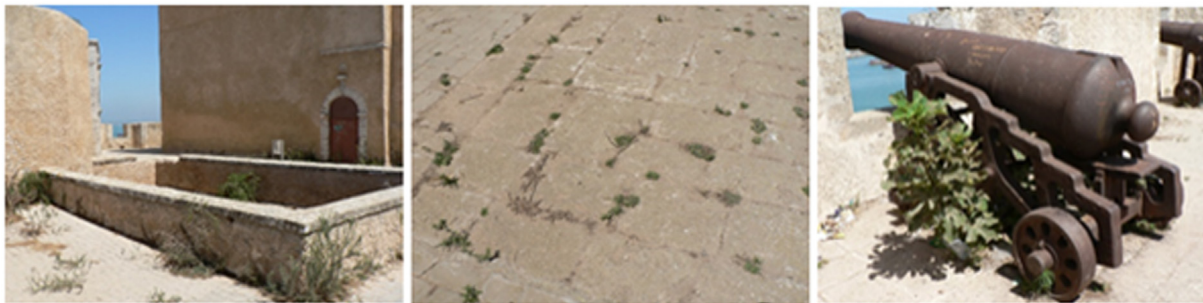
The base of the walls and the joints of the paving often have a loose appearance (Fig. 8). The substrate is then sandy to clay and has locally varying contents of granular elements sometimes rich in fragments of lime coming directly from the wall coatings.

Fig. 8. The vegetation invades the joints of less resistance.
