# Journal of King Saud University - Science

# Dam safety assessment using 2D electrical resistivity geophysical survey and geological mapping

W.O. Raji a,b,\*, A.D. Adedoyin b

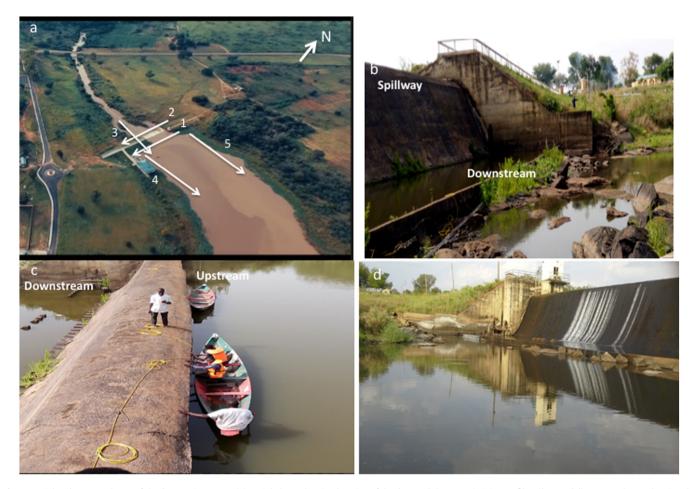
When measuring resistivity data along profile 1, the electrodes were inserted into water along the dam axis because the water level was higher than the electrodes' height. Two canoes were used by the field crew to move from one end of the dam to another while laying the cables/electrodes (Fig. 2c) and measurements were taken when the cables were stable. The practicality of laying electrode in water-covered area for 2D Resistivity Survey and its

data processing is described in Loke and Lane (2004) and Lagmansson (1998). In profile 2, water level is lower than the height of electrodes, but the electrodes are in contact with water (Fig. 2b). For profiles 3, 4 and 5 electrodes are grounded following the conventional procedure. Profiles 1 and 2 were laid in approximate north-south direction, while profiles 3, 4 and 5 were laid in approximate east-west direction. The survey was designed to penetrate to a depth greater than 30 m, which is the maximum depth to the basement rock in the area (Olasehinde and Raji, 2007; Raji and Ibrahim, 2017). The survey took place in January 2017 at the peak of dry season when the dam's water is at its minimum. In addition, part of the dam's water was drained to allow resistivity measurement.

Fig. 2. Aerial and camera photos of the dam environment. (a) Aerial photo showing location of the dam and the 2D resistivity profiles; (b, c, and d) camera photos showing the different sections of the dam.
